# SECOND FLOOR

## THE NORTH CHAMBER

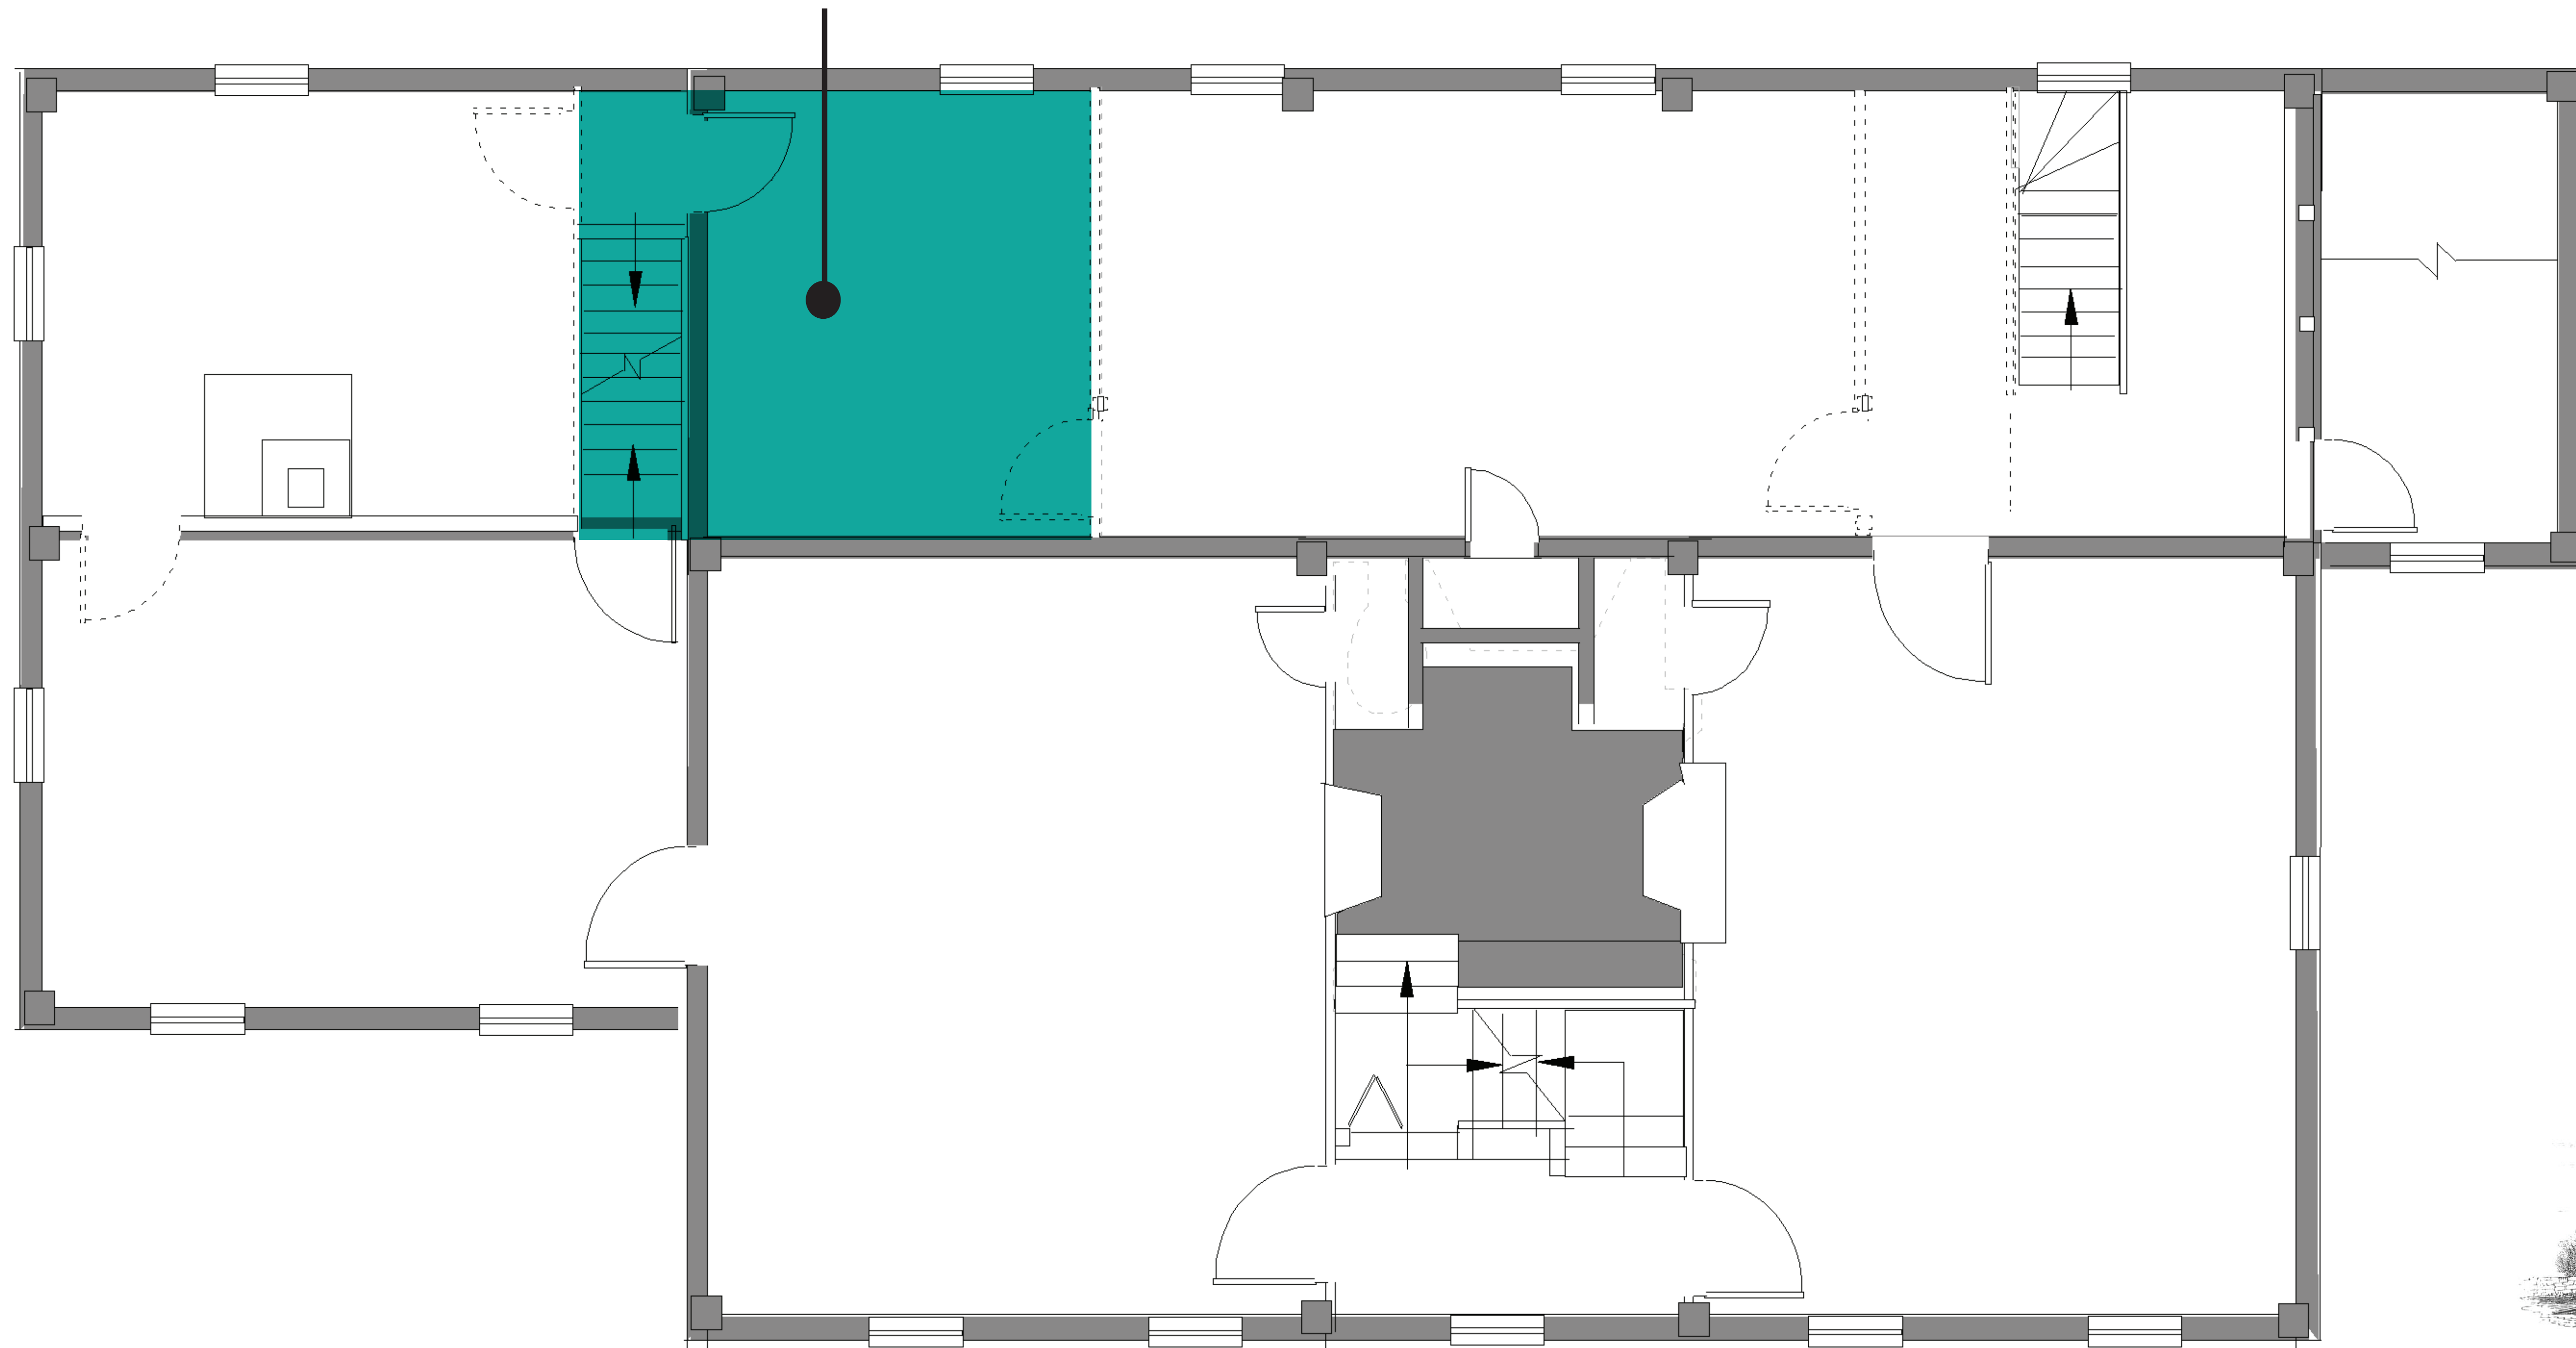
**Original Features:** Floor frame evidence of former stair below, Muster Room closet lock in partition, doors, hardware.

**Later Alterations:** Second floor rear added ca. 1810s; extensive decay caused rebuilding ca. 1911, again 2007-9.

**Restorations:** Ca. 1810s framing duplicated, 6-over-9 windows restored to match evidence for originals.

**Finishes:** Early plaster south wall; plain board partitions originally unpainted, painted in 19th-20th centuries.
